Fatigue Behavior of Ti-6-4 Alloy with Application of Calcium Phosphate

THESIS

MASTER OF SCIENCE

in Materials Science & Engineering

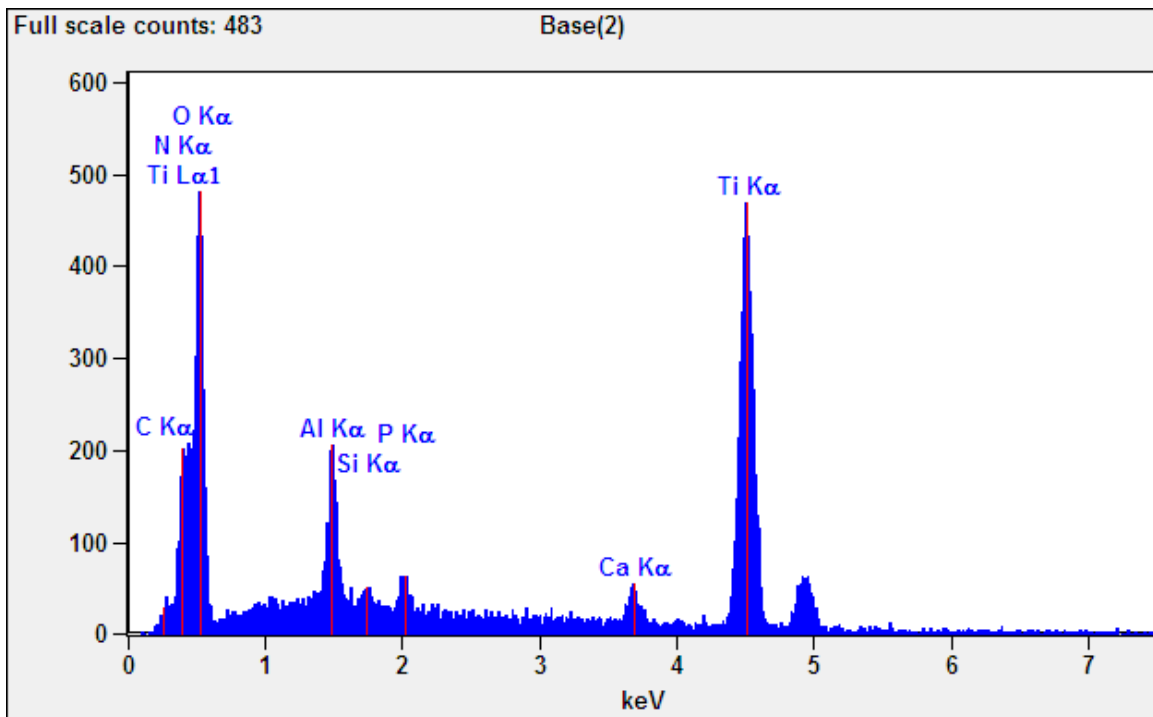
Figure 3.1: EDS mapping of substrate and coating

To determine the surface coating presence, energy-dispersive X-ray spectroscopy (EDS/EDX) was used. Different areas of the coated samples were chosen to perform EDS and retrieve information via both spectrum and mapping. Figure 3.1 shows various peaks

of the elements that are picked up by EDS. These elements are representative of both the ones contained in the titanium alloy as well as the surface coating. The goal here is to show that the calcium phosphate does indeed exist at the surface of the substrate. Higher peaks of titanium (Ti) and aluminum (Al) are seen as expected whereas peaks of calcium (Ca) and phosphorus (P) are comparatively lower.

This shows that the calcium phosphate coating does exist at the substrate however, the EDS mapping images would further explain the uniform presence of the coating across the surface.

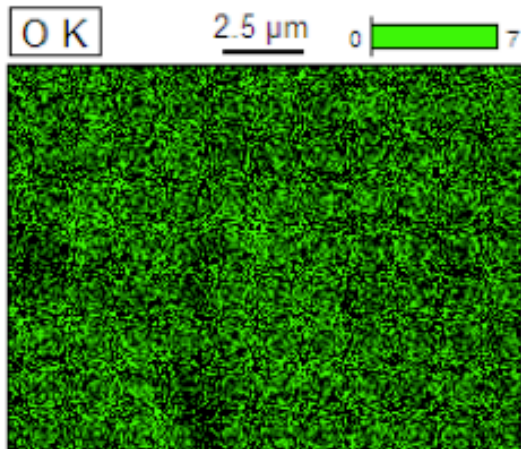
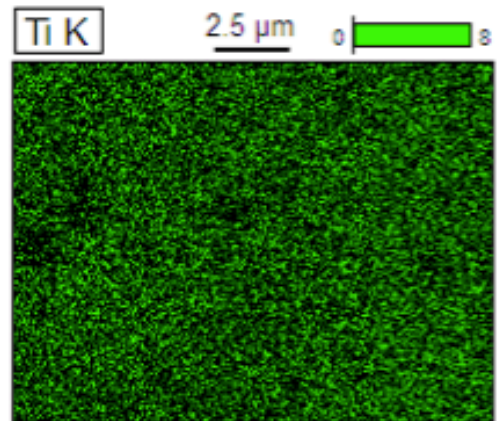
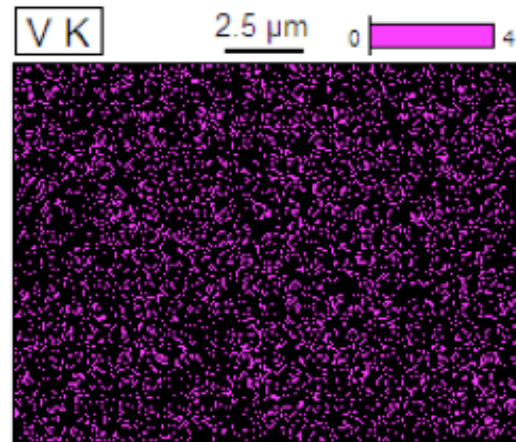
Figure 3.2(a): Area sampled in EDS

Figure 3.2(b): Detection of calcium

Figure 3.2(c): Detection of oxygen

Figure 3.2(d): Detection of Aluminum

Figure 3.2(e): Detection of Silicon

Figure 3.2(e): Detection of Phosphorus

Figure 3.2(g): Detection of Calcium

Figure 3.2(h): Detection of Titanium

Figure 3.2(i): Detection of Nitrogen

Figure 3.2(j): Detection of Vanadium

Figure 3.2(a) is the area that is being mapped to show which part of the sample was chosen for the mapping. From these images we can confirm that the calcium phosphate coating is uniformly spread throughout the substrate. A small count of silicon is apparent on the material as well but this is most likely due to dust particles that the material may have picked up. Also notice that the titanium substrate is significantly higher in terms of counts, which is expected since the coating is relatively thin.

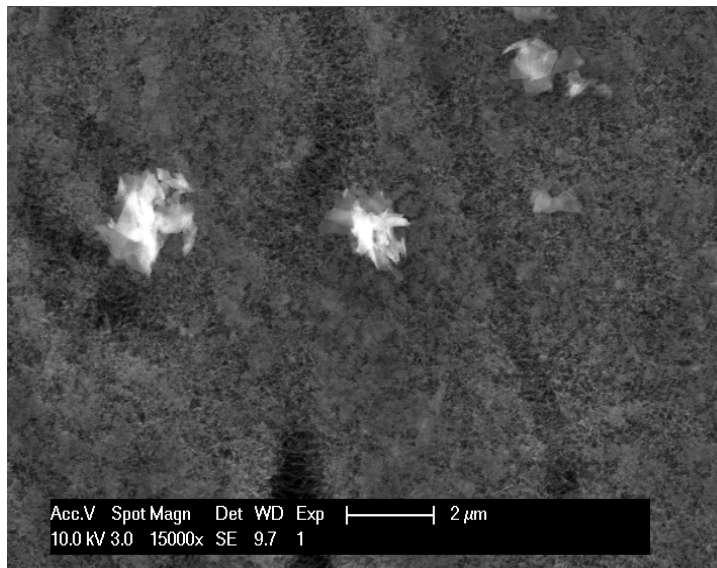
Figure 3.3(a): Precipitates found at surface of coated samples

Figure 3.3(b): Higher magnification of area seen in Figure 3.4(a)

Throughout the surface of the material, precipitates can be found scattered in a random fashion. First thought is that these are part of the calcium phosphate coating and are rather clumps of slat built up together as seen in Figure 3.3a. To confirm that these

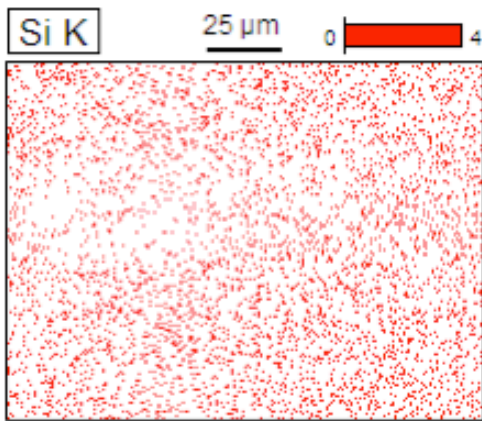
Figure 3.5(a): Precipitate on substrate

Figure 3.5(b): Calcium presence

Figure 3.5(c): Oxygen presence

Figure 3.5(d): Phosphorus presence

Figure 3.5(d): Calcium presence

Figure 3.5(e): Titanium presence

Figure 3.5(f): Silicon presence

Figure 3.5(g): Nitrogen presence

Figure 3.5(h): Vanadium presence

Figure 3.5(i): Aluminum presence

From these images we see that the area and precipitate that was chosen for EDS mapping gives a much higher count of calcium and phosphate than does silicon or the substrate elements, namely titanium. Therefore this confirms our speculation of the precipitates indeed being due to the calcium phosphate coating.

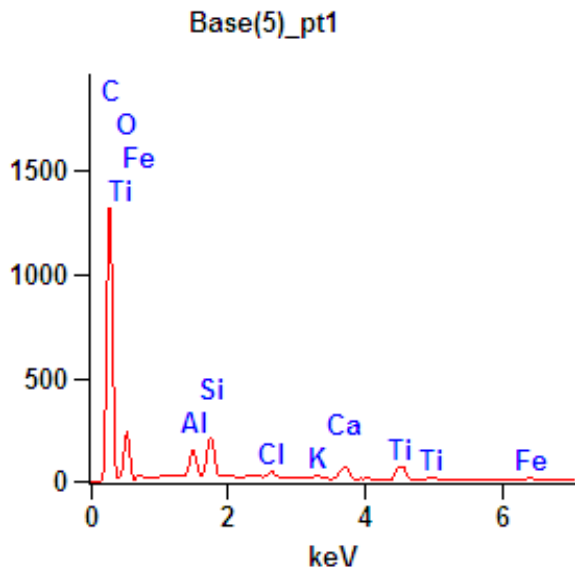
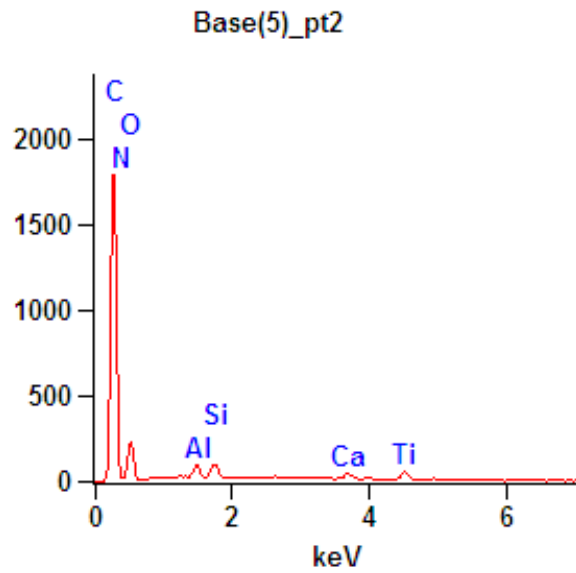
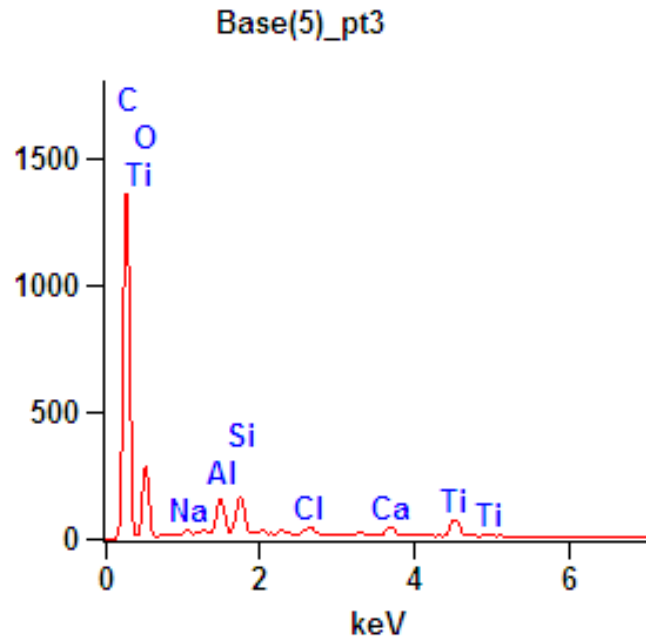
Figure 3.12: Three different points selected along the coating in EDS.

Figure 3.13(a): Spectrum for point 1

Figure 3.13(b): Spectrum for point 2

Figure 3.13(c): Spectrum for point 3

EDS on. For this selected area (Figure 3.12), three different points were selected along the coating. This confirms that the thin layer is indeed the coating. However, still only a calcium peak could be identified. Since the calcium peak is already relatively small, and the calcium to phosphorus ratio is one to two, it is probable that one of the much smaller peaks that were not identified is phosphorus. From this layer, the coating was thus measured and found to be about 2 μm in thickness.
