Child with Testicular Pain

Clinical Practice and Cases in Emergency Medicine, 2(1)

## Child with Testicular Pain

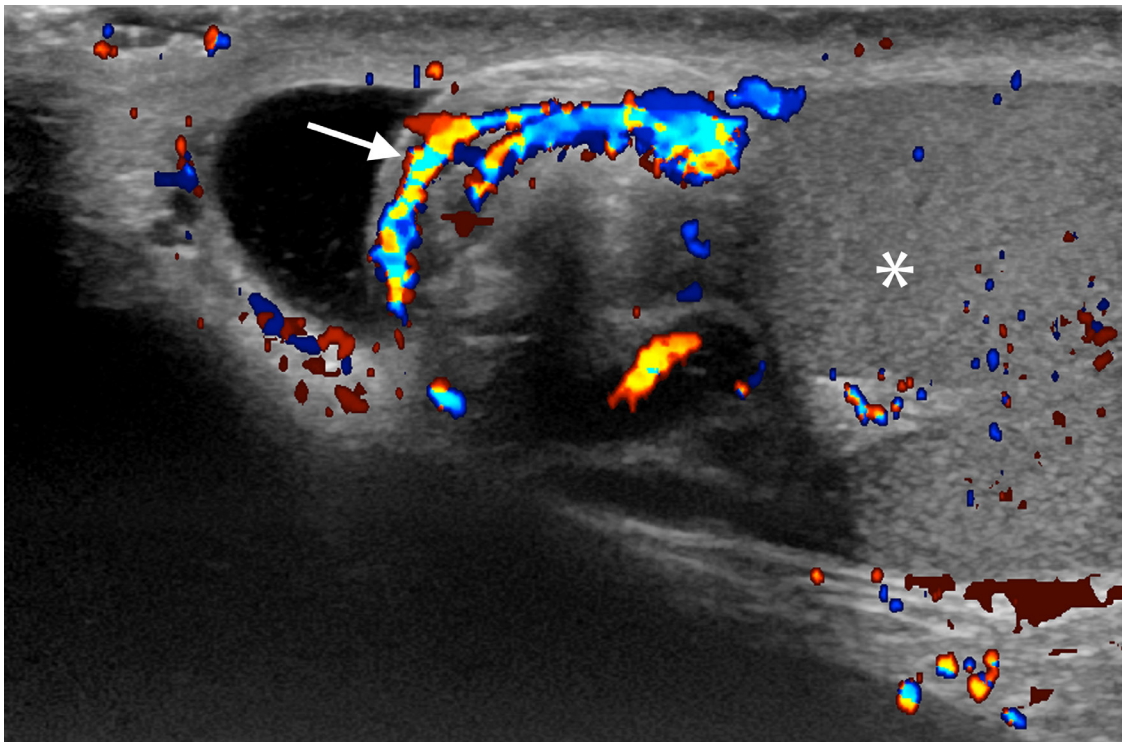
**Image 1.** Ultrasound of the spermatic cord demonstrates an edematous, heterogeneous extra testicular mass representing the twisted spermatic cord, with whorled color flow, the “whirlpool sign”(white arrow) around a central axis. Immediately adjacent is the testicle (white asterisk).

the whirlpool sign seen on point-of-care ultrasound (POCUS) of spermatic cord (Image).

early adolescence. Evaluation of testicular flow by color and spectral Doppler is the primary method of diagnosis.<sup>1</sup> However, evaluation with Doppler can be non-diagnostic due to the presence of low-velocity blood flow. Direct visualization of the spermatic cord by POCUS may elicit the whirlpool sign or an echogenic mass twisted around a central axis. As demonstrated by this case, whirlpool sign is diagnostic of torsion and can help identify torsion when Doppler is non-diagnostic.<sup>2,3</sup> Thus, the whirlpool sign, although not frequently mentioned in emergency medicine literature, can be critical to the diagnosis of torsion in the ED and should be an ultrasound finding known to all emergency physicians.

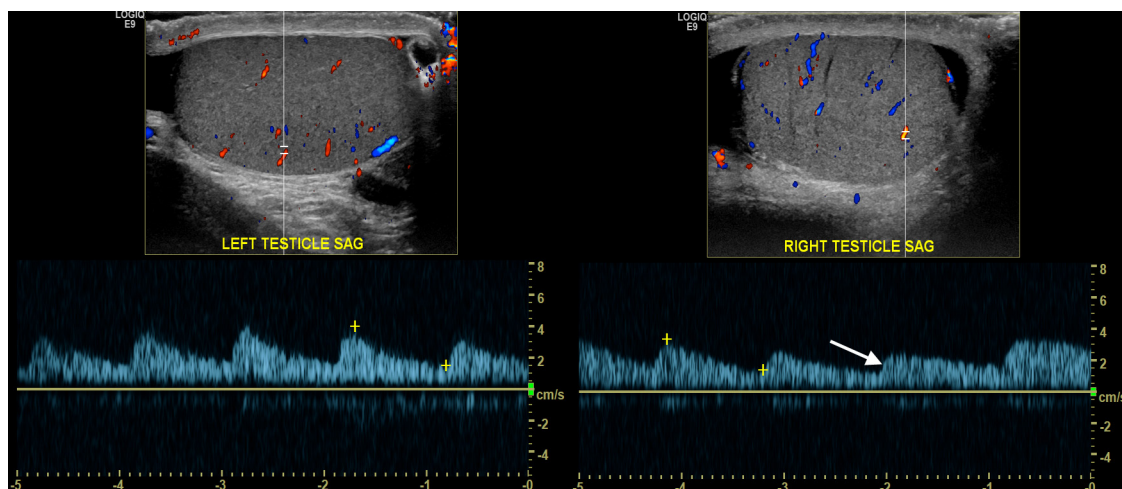
**Image 2.** Transverse ultrasound image of the left testicle obtained with a 15Mhz linear-array transducer using spectral Doppler demonstrates normal arterial wave form and flow (2A). Spectral Doppler of the right testicle (white arrow) demonstrates comparatively decreased systolic velocities with slowing of the upstroke (2B).

An 11-year-old boy presented to the emergency department (ED) with sudden onset severe atraumatic right testicular pain, associated with nausea and vomiting. On examination, the patient exhibited a slight horizontal lie of the right testicle as well as an absent cremasteric reflex on the right. Urology was emergently consulted. Though vascular flow was noted bilaterally on spectral Doppler (Images 2), the patient underwent surgical detorsion due to
